# Railway Farmhouse Fen Lane Scarning

## Architectural History

NHER: 22126  
GR: TF9765 1222

## Railway Farmhouse, Scarning

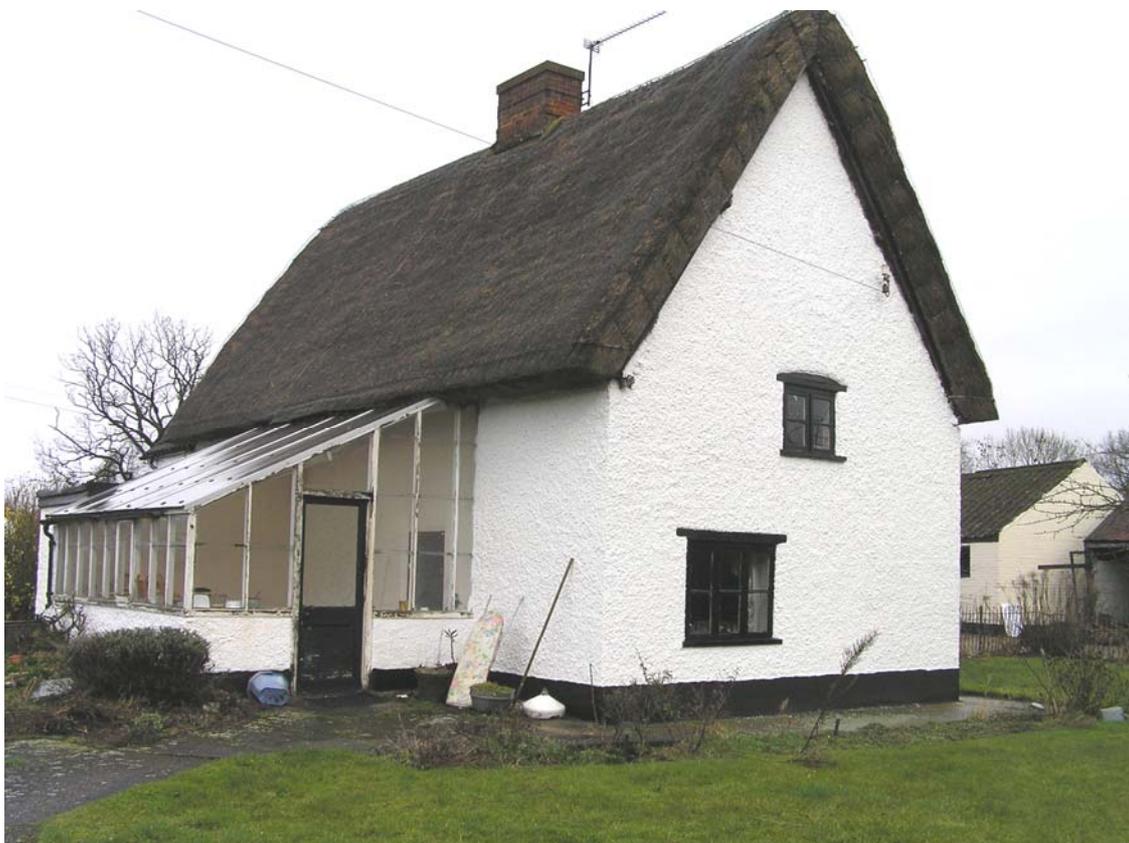
Fig 1 General view from south west

The building is a plastered timber frame with a thatched roof of long straw and flush ridge (fig.1). The plastered walls have been covered with modern roughcast. In plan the building is essentially two-cell with a central axial stack with stair and one-and-a-half stories. Various single storey additions have been made. The extension shown to the south west shown on the plan is now a conservatory possibly built on the foundations of the former extension. (If it was a conservatory the plan would show the extension cross hatched). The earliest extension is to the north-west and now has modern tile roof. Perhaps, this was built on the site of the original service rooms which would have occupied this position in the traditional farmhouse plan. A careful inspection of the surviving frame forming the north east wall would determine whether or not there was an original service bay. The original entrance, now blocked was into a lobby opposite the stack. This is a typical plan type of the later 16<sup>th</sup> and 17<sup>th</sup> centuries.

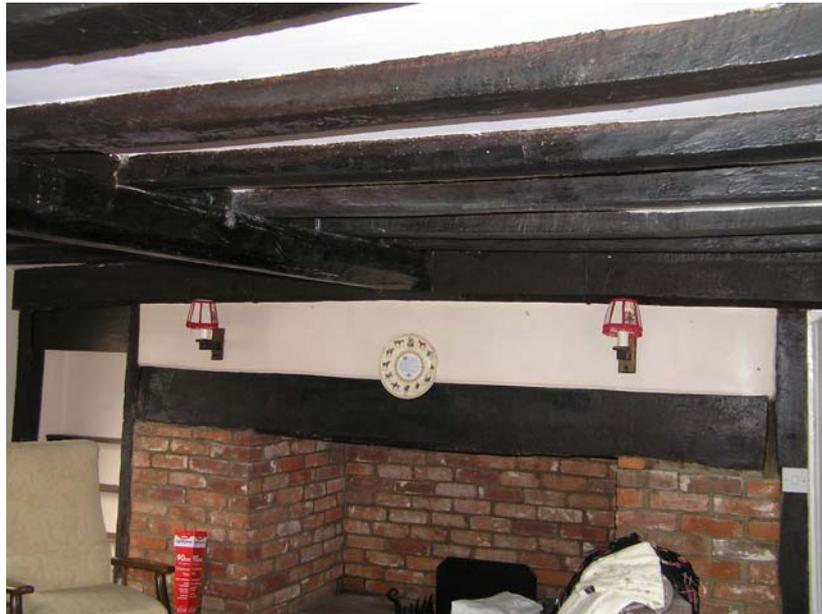
The ceilings of both bays survive with spinal bridging joists each joining onto transverse beams against the stack. These are decorated with chamfers with ogee stops (fig. 3 and 4).

Fig 3 Ceiling of south-west cell with rebuilt hearth.

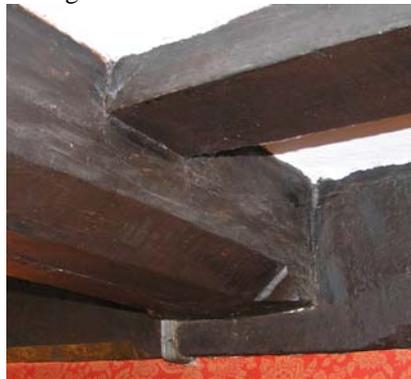
Fig 4. detail of chamfer stop

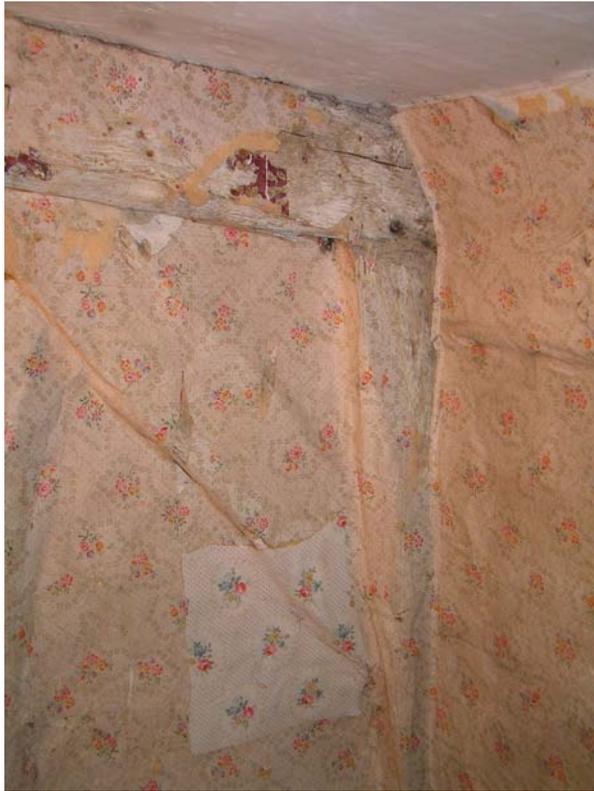
The frame is largely but a jowled principal post, tie and brace can be seen at the upper floor level disguised by wall paper (fig. 5).

Fig. 5. View showing principal post, wall plate, tie beam and brace.  
North-east stack bay at upper floor.

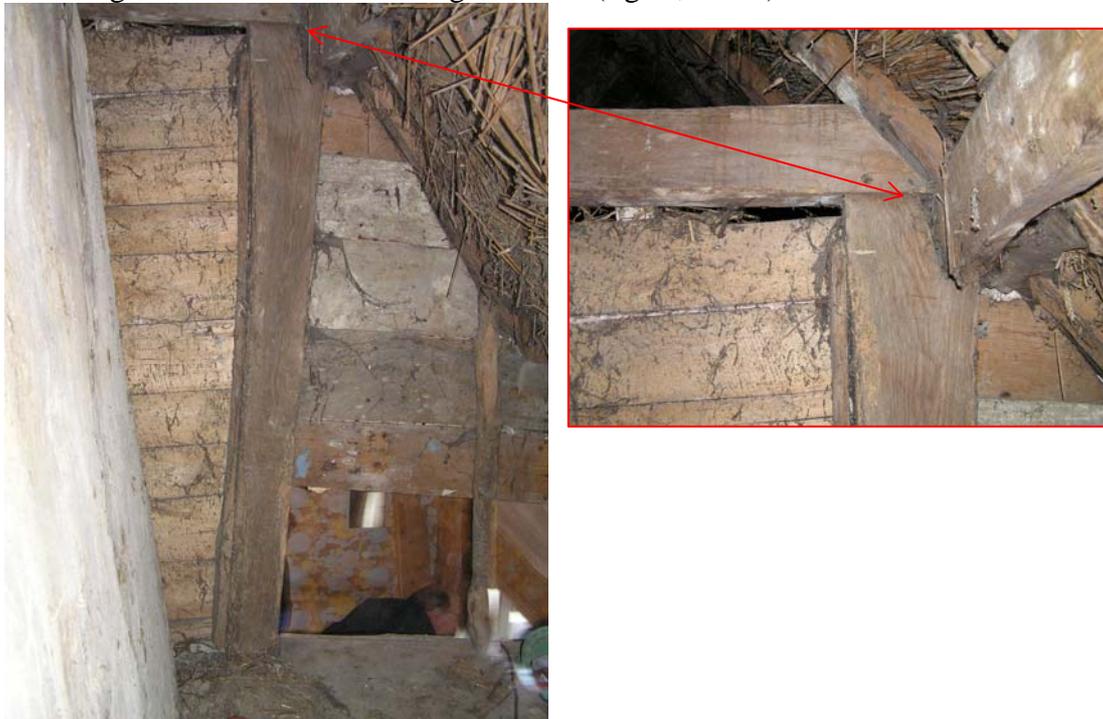
The roof structure is of particular interest because it is of queen post construction with surviving trusses at the centre and gable ends (figs 6, 7 & 8).

Figs 6 & 7. North east queen post and detail of collar, post, purlin joint.

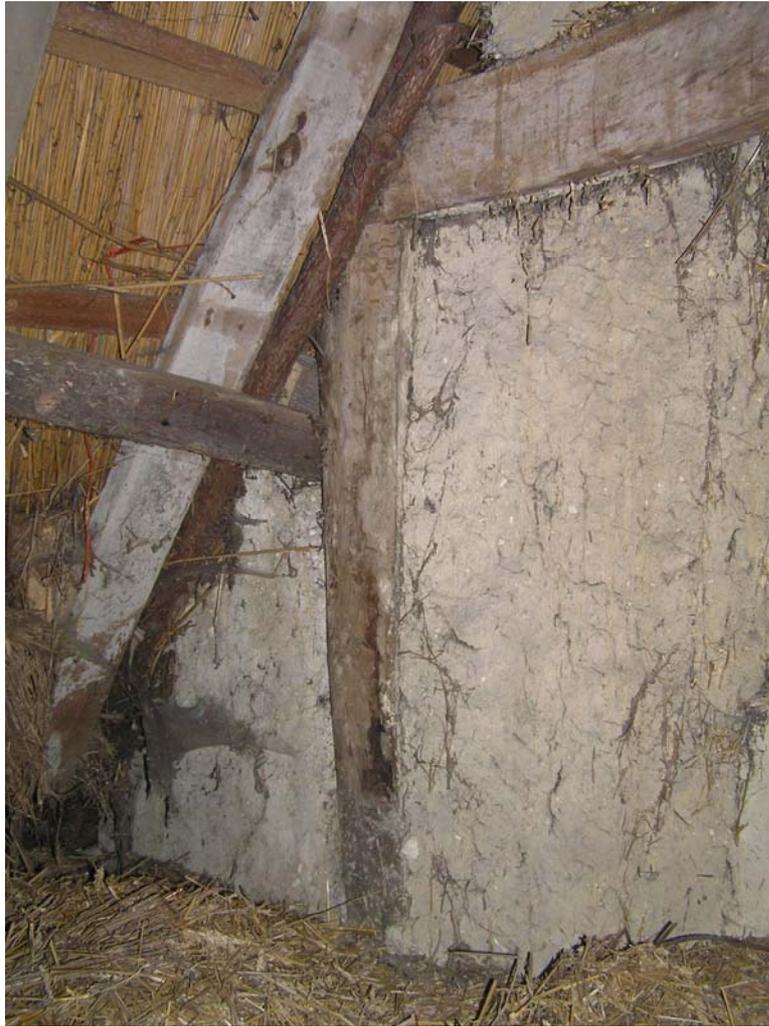
Fig. 8. South-west queen post with original purlin lost.

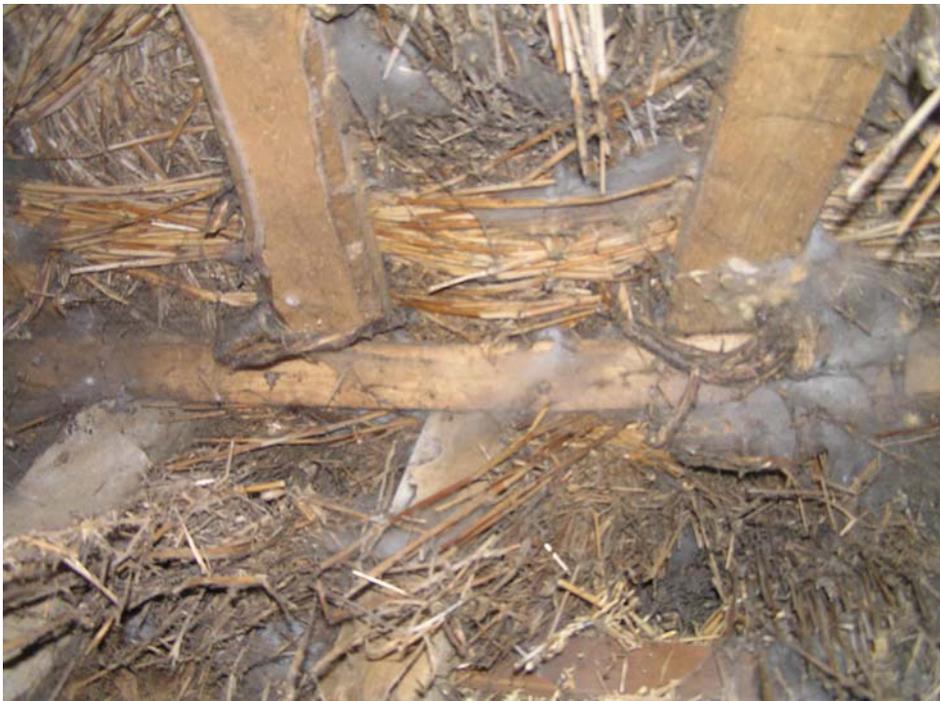
Queen post trusses consist of a pair of vertical posts rising from the tie beam. The posts have wider or jowled tops in order to accommodate the purlin, which is triangular in section, and also the collar. This roof also has a ridge purlin also probably of triangular section (fig.9).

Fig. 9. Ridge purlin.
